National Pollutant Discharge Elimination System

**MUNICIPAL SEPARATE STORM SEWER SYSTEM
DISCHARGE PERMIT NUMBER: MD0068365
STATE DISCHARGE NUMBER: 11-DP-3322**

**CHARLES COUNTY, MD
ANNUAL REPORT
JULY 2018 - JUNE 2019**

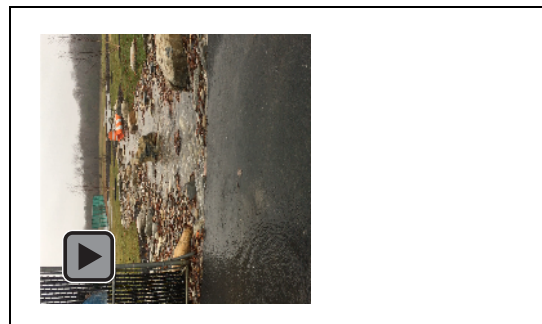
The PTRC was awarded a grant to implement outdoor classroom project which was designed prior under a 2017 Watershed Assistance Grant. The implementation included construction of stormwater amendments including a swale to manage runoff from an adjacent parking area and associated plantings. The project was completed in the Fall of 2018. A video shows the swale functioning during a rain event.

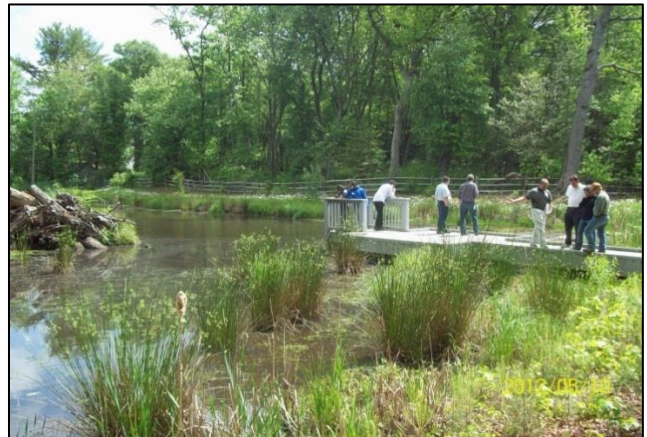
**Bryans Road Watershed Restoration Project
(dry swale, under-ground storm filter with
the community park above):** Design began in
FY 2007 and project completed in FY 2013.
(County Permit # VCI 090078)

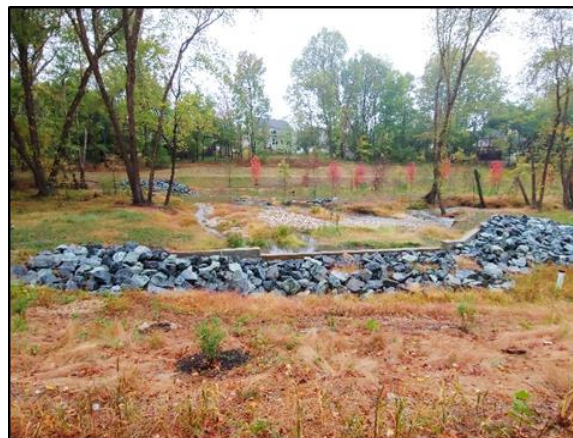
Acton Hamilton Watershed Restoration Project (submerged gravel wetland and wetland restoration): Design complete in January 2017 and construction began July 2017. (County Permit # VCI 120088)

Estimated Impervious Treatment: 36.85 acres

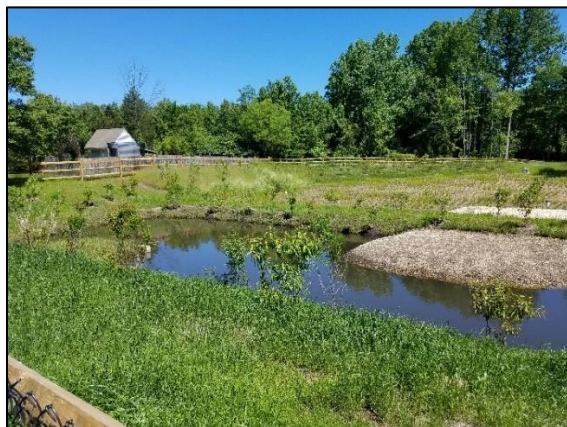
Temi Drive Watershed Restoration Project (submerged gravel wetland): Design began in FY 2013. Construction began February 2016. (County Permit # VCI 130063)

Estimated Impervious Treatment: 15.2 acres

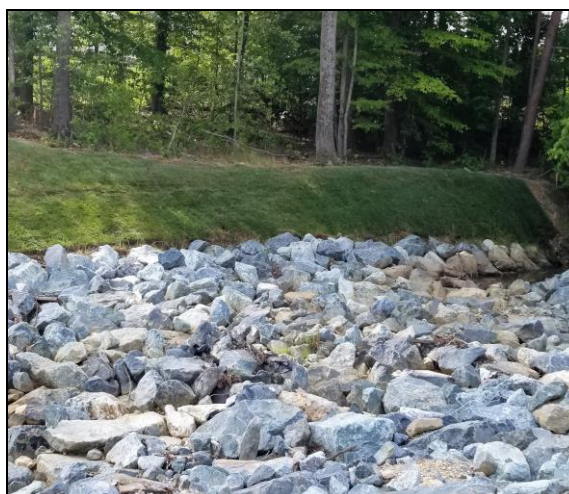
Fox Run Watershed Restoration Project (step pool storm conveyance): Design process began in FY2012, and construction complete in FY 2015.
(County Permit # VCI 110102)

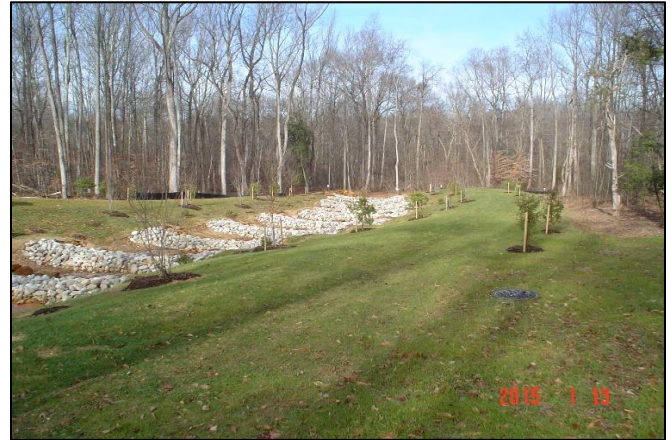
Ryon Woods Watershed Restoration Project (grass swales with check dams): Design began FY 2012.
(County Permit # VCI 110099)

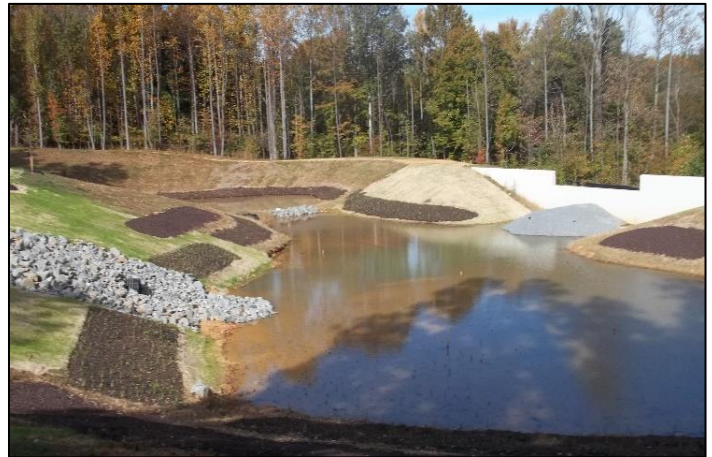
Acton Lane Stormwater Management Facility Project (wet pond):

Design began in FY 2009.
Construction started in May 2014.
(County Permit # VCI 040021)

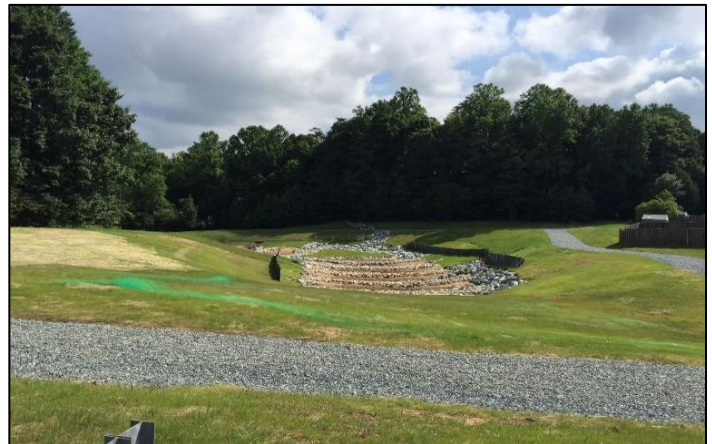
Tanglewood Watershed Restoration Project (step pool storm conveyance):

Design began in September 2014.
Construction started December 2015.
(County Permit # VCI 150005)

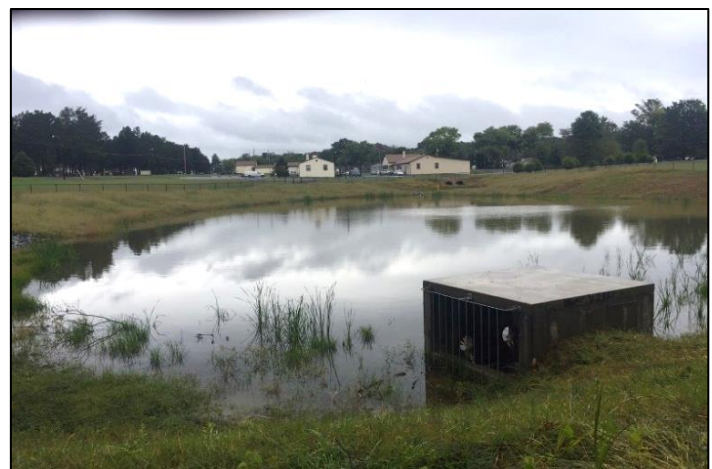
Potomac Heights Stormwater Management Facility Project (wet pond and swales):

Design began in October 2009.
Construction started in February 2015.
(County Permit # VR 120095)

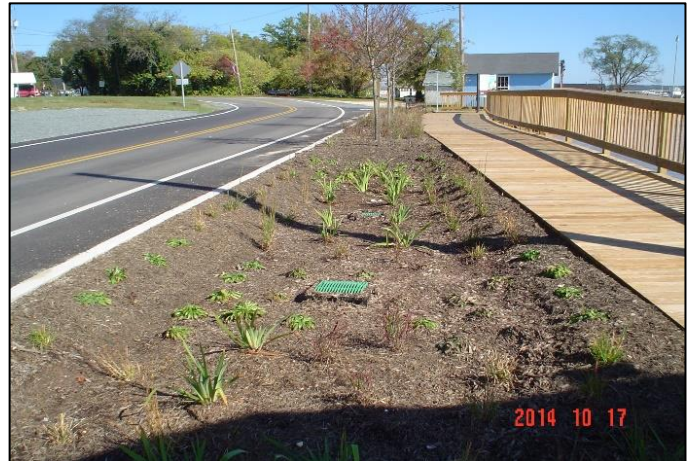
***Benedict Village Enhancements Project
(rain garden):***

Design began in July 2013.
Construction started in July 2014.
(County Permit # VCI 140021)

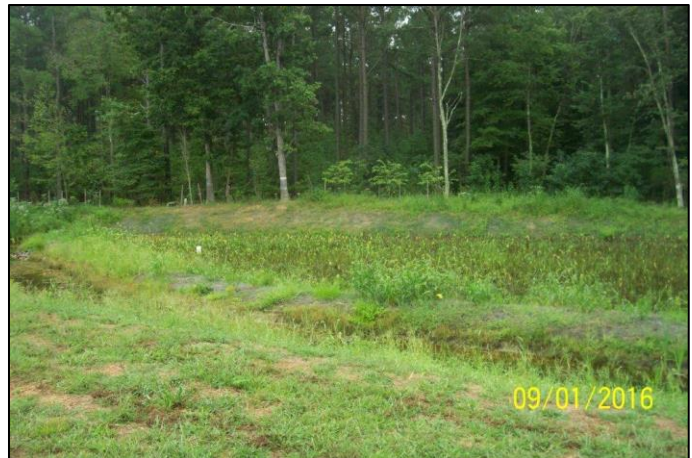
***Tenth District Stormwater Management
(shallow gravel wetland/with grass swales):***

Private project. Construction started in January 2016.
(County Permit # VC 140006)

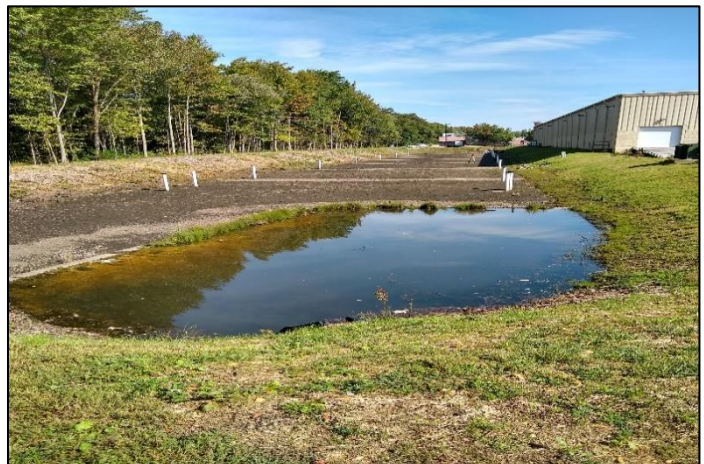
Charles County Plaza (shallow gravel wetland):

Design completed September 2016.
Construction started July 2017.
(County Permit # VCI 150024)

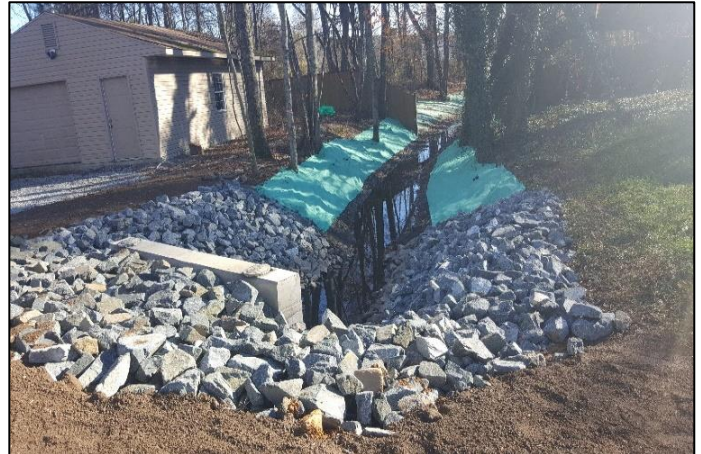
Pinefield Drainage Improvements (Storm Drain Cleaning - removal of 2,824 tons sediment):

Design completed November 2015.

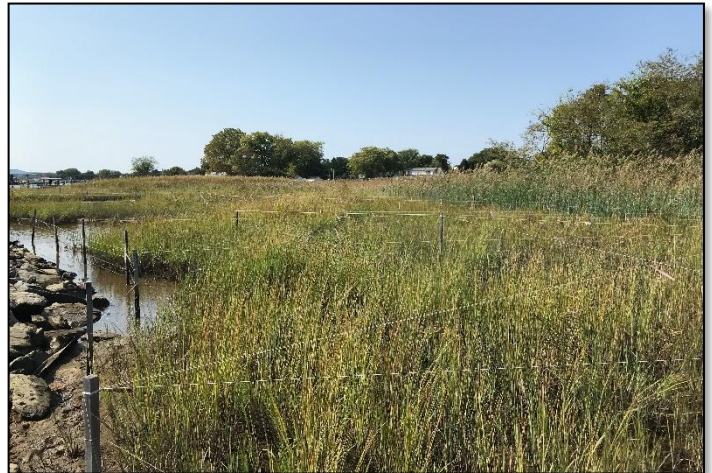
***Benedict Shoreline Stabilization:***

Design completed August 3, 2017.

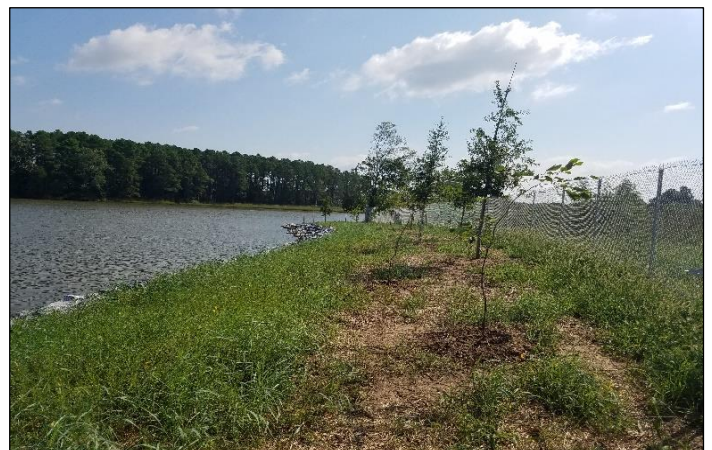
***Swan Point Shoreline Stabilization:***

Design completed May 2017.

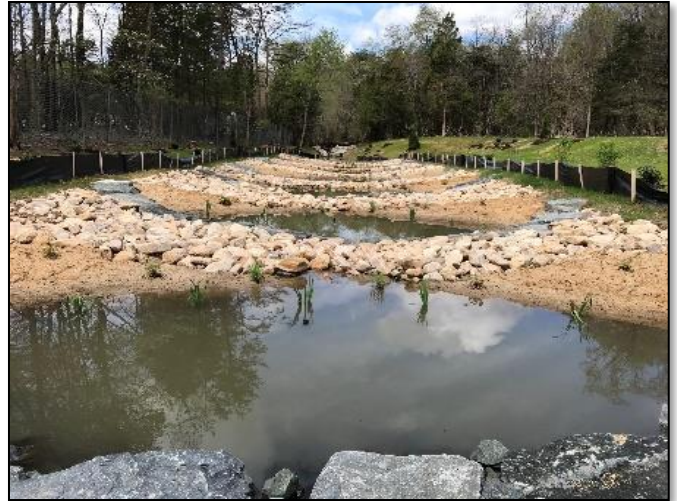
**Charles County Department of Public Works
(step pool storm conveyance):**

Design completed March 2017.
Construction began August 2018.
(Town of La Plata Permit # 0315)

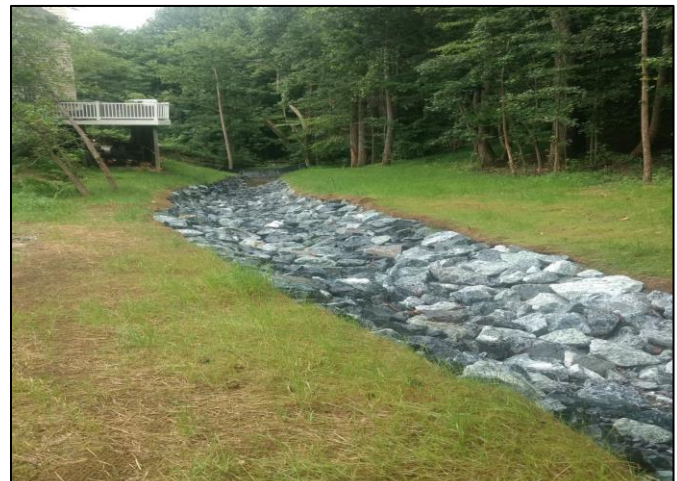
Longmeade Lot 9 Outfall Stabilization:

Design completed December 2017.
Construction began August 2018.
(County Permit # VCI 170049)

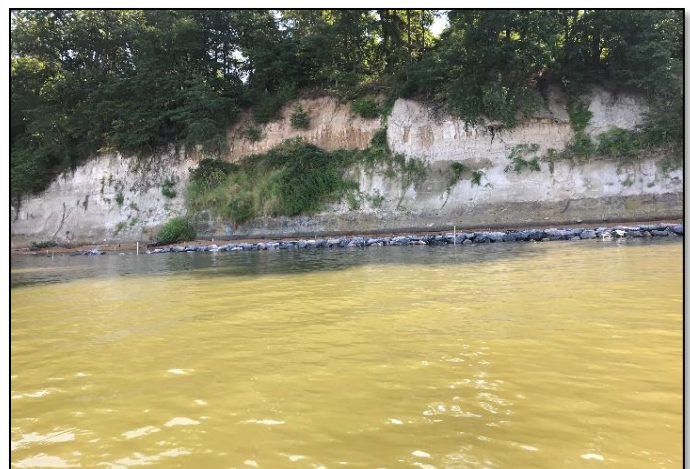
Cliffton Shoreline Stabilization Phase 1&2

Design completed August 2017 Phase 1.
Design completed May 2019 Phase 2.
Construction began July 2019.
(County Permit # VCI 160056 Phase1)
(County Permit # VCI 170096 Phase2)

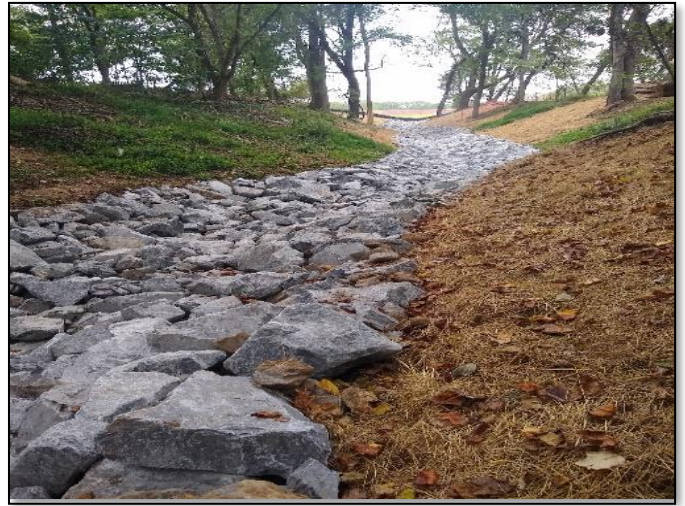
***Bensville Park Stormwater Retrofits,
Outfall Stabilizations and Tree Planting***

Design completed September 2018

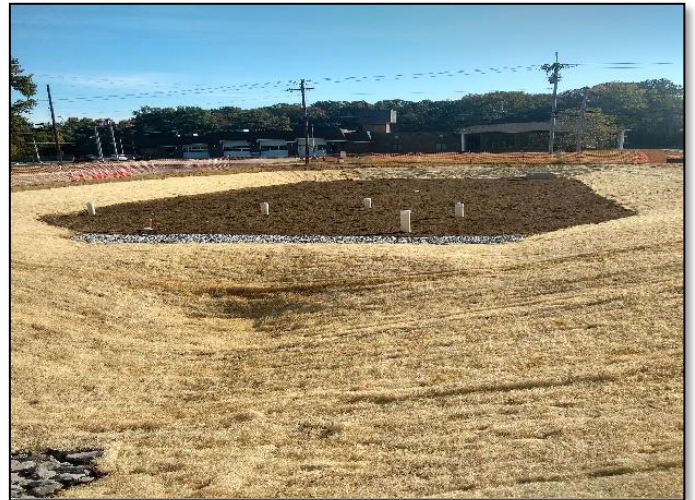
***General Smallwood Middle School***

Design completed February 2019.

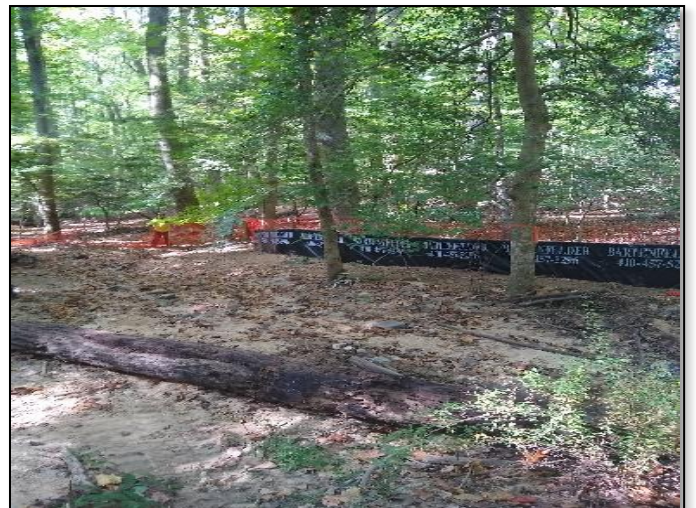
***Apple Creek Stream Restoration***

Design completed May 2019.

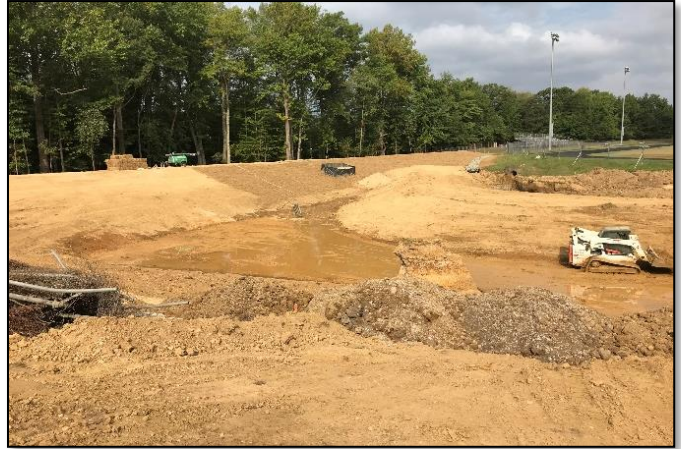
LaPlata High School Stormwater Retrofit

Design completed May 2018.
Construction began May 2019.
(County Permit # N/A)

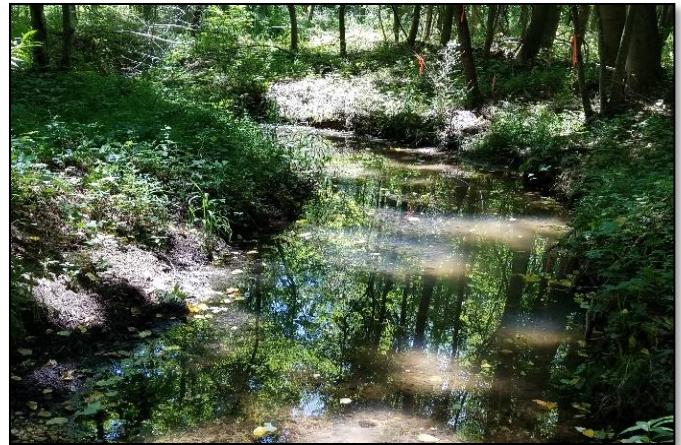
St. Charles Parkway Stream Restoration

Design completed August 2019.
Construction began December 2019.
(County Permit # VCI 170053)

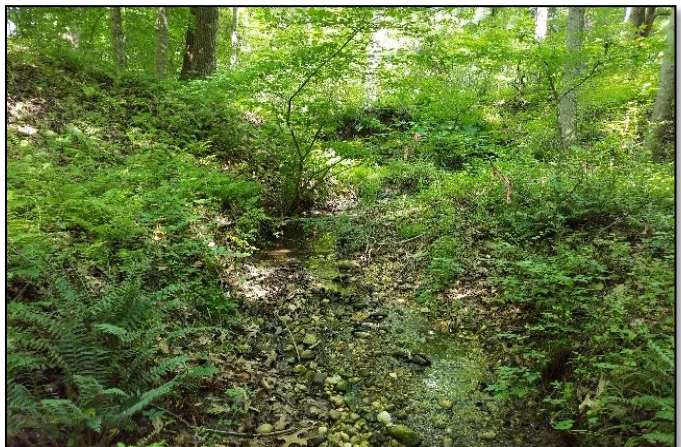
Thomas Higdon ES Stream Restoration

Design completed August 2019.
Construction began December 2019.
(County Permit # VCI 170071)

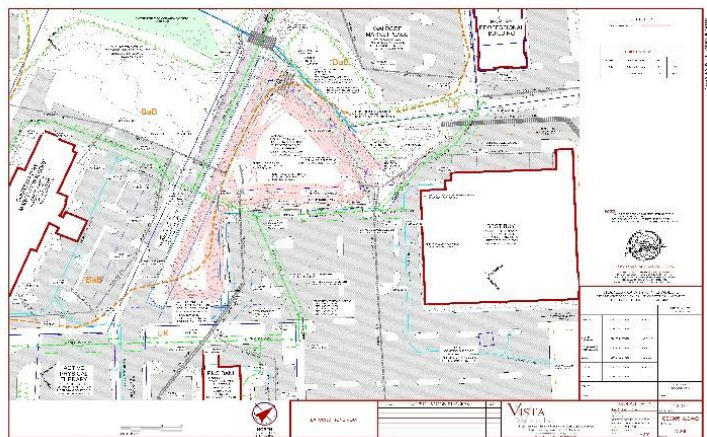
Potomac Heights Shoreline Restoration

Design completed September 2019.

*Impervious Treatment: 4.62 acres**Approx. cost per acre treated: \$70,455**Status: Construction – (Awaiting Contract)*

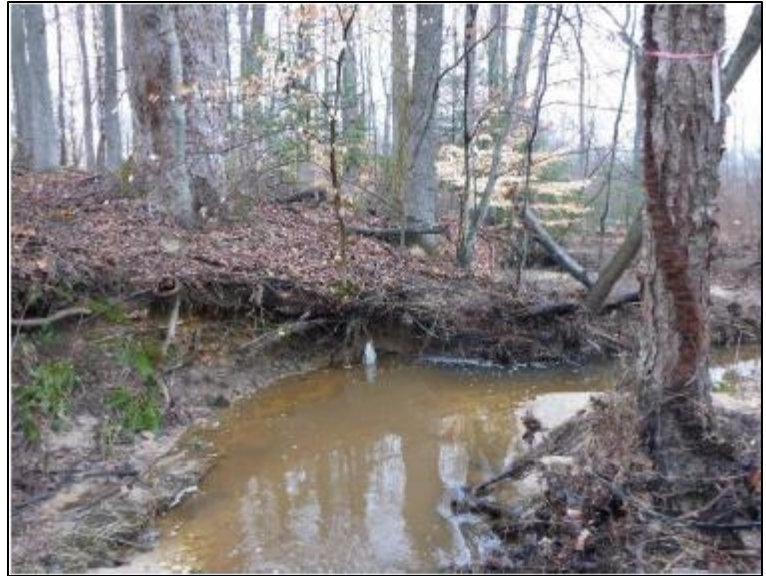
changed considerably since the baseline survey. This is in association with the tree on the right bank that became uprooted between 2009 and 2013, increasing the cross sectional area. Despite these changes, the reaches associated with these cross sections do not show evidence of larger scale incision or widening.

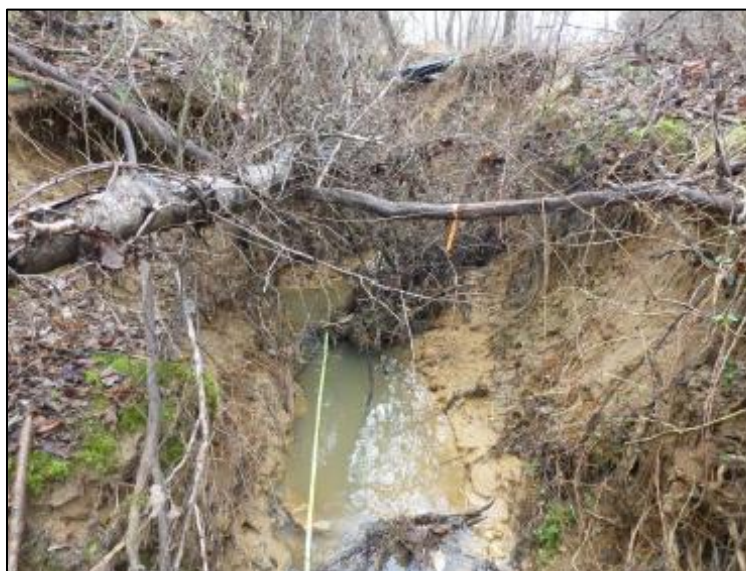
increased to 5.5 feet. Cross Sections 1 and 2 remain stable and no changes were noted. Cross Section 3 continues to have a small channel inset in a floodplain made up of fine sediment deposition, which was first noted in 2013. The source of the silt appears to be the stormwater pond, as there is no erosion in the outfall channel upstream of this cross section. The continued release of fine sediments from the pond may indicate that it is not functioning correctly, and therefore an evaluation is recommended.
